Last Check Vehicle Inspection

VIBE Report

Make: RENAULT

Model: 4007

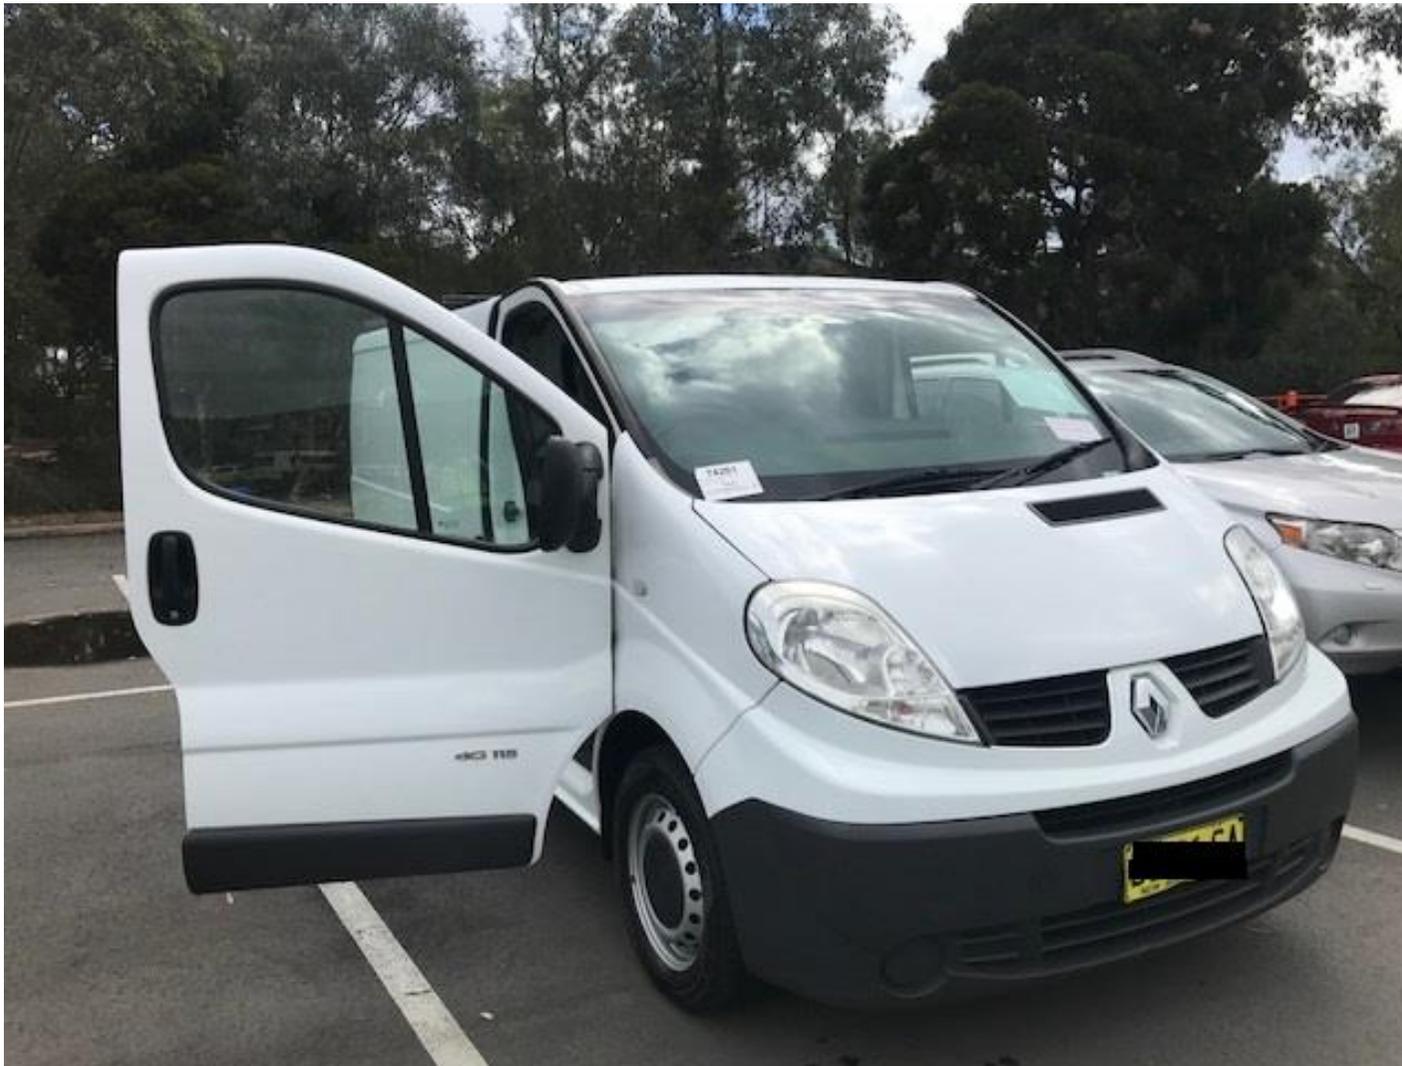
NOTE: 31 IMAGES HAVE BEEN TAKEN FROM THE VEHICLE _ SEE ALL THE IMPERFECTIONS IN REAL LIFE
